# Manhole Inspection Summary

Manhole # S25AA\_014MH

Insp Date: **9/14/07 9:30 AM**

**Location** Address: **800 CARROLLTON AVE**

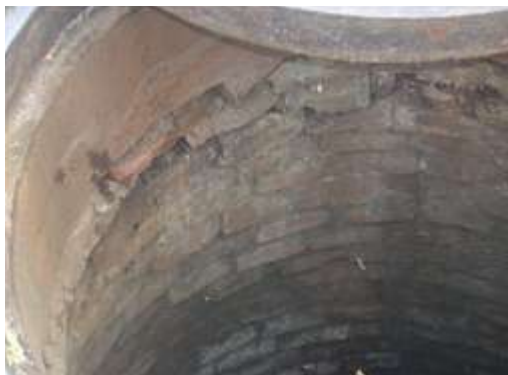
Defect 4

Condition: ☐ Sound ☐ Cracked ☐ Root Intrusion ☒ **Loose Brick** ☒ **Deteriorated**

LOOSE CORBEL BRICKS

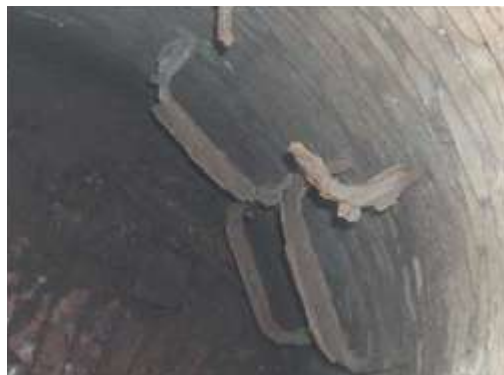
Defect 3

Count: **3** Missing: **1** ☒ **Corroded**

MISSING AND CORRODED STEPS

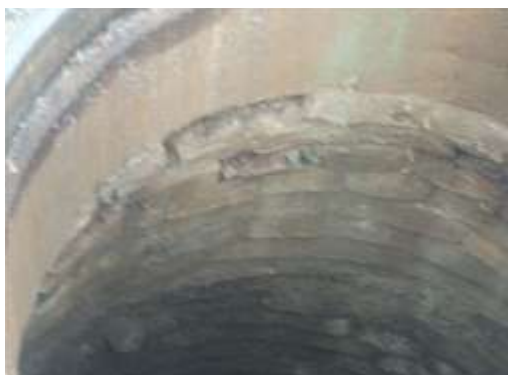
Defect 2

DETERIORATION OF CORBEL

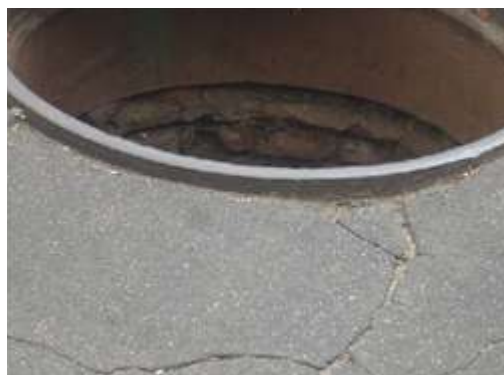
Defect 1

Diameter: **24** (in.) Length: (in.) Dist A/B Grade: **1** (in.)

GRADE ADJ.

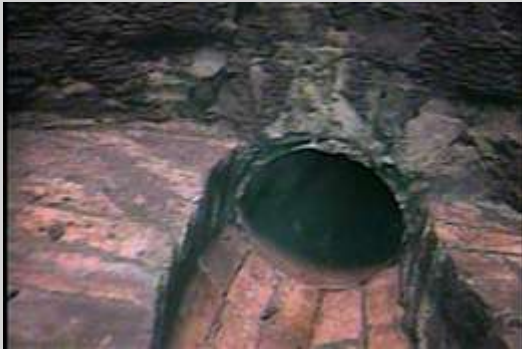
12 O'Clock Outflow

8 in. Circular Gravity Sewer  
Pipe Out @ 12 O'Clock

Pipe Height: **7.2** (in.) Rod and Bar (Angled)  
Pipe Material: **Clay** ☐ Pipe Lined  
Invert Depth: **9.27** (ft.) Flow Characteristics: **None**  
Deposits: ☒ None ☐ Mud ☐ Sludge ☐ Debris ☐ Grease  
Silt Depth: (in.) Deposits Extent:  
Infiltration: **None** Pipe Seal Cond: **Sound**

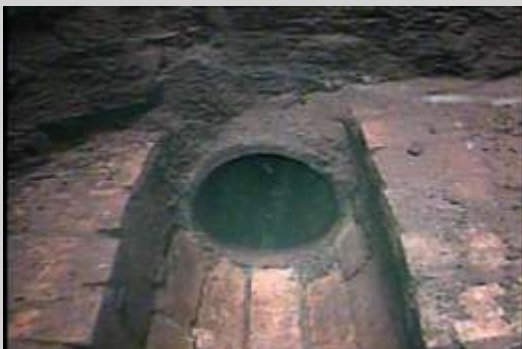
4 O'Clock Inflow

6 in. Circular Gravity Sewer  
Pipe In @ 4 O'Clock

Pipe Height: **6** (in.) Rod and Bar (Angled)  
Pipe Material: **Clay** ☐ Pipe Lined  
Invert Depth: **8.84** (ft.) Flow Characteristics: **None**  
Deposits: ☒ None ☐ Mud ☐ Sludge ☐ Debris ☐ Grease  
Silt Depth: (in.) Deposits Extent:  
Infiltration: **None** Pipe Seal Cond: **Sound**
